**Preliminary  
Contamination  
Review (PCR)**

Lots 400-500 Astra  
Aerolab, Williamtown NSW

NEW24P-0090-ABv3  
23 May 2024

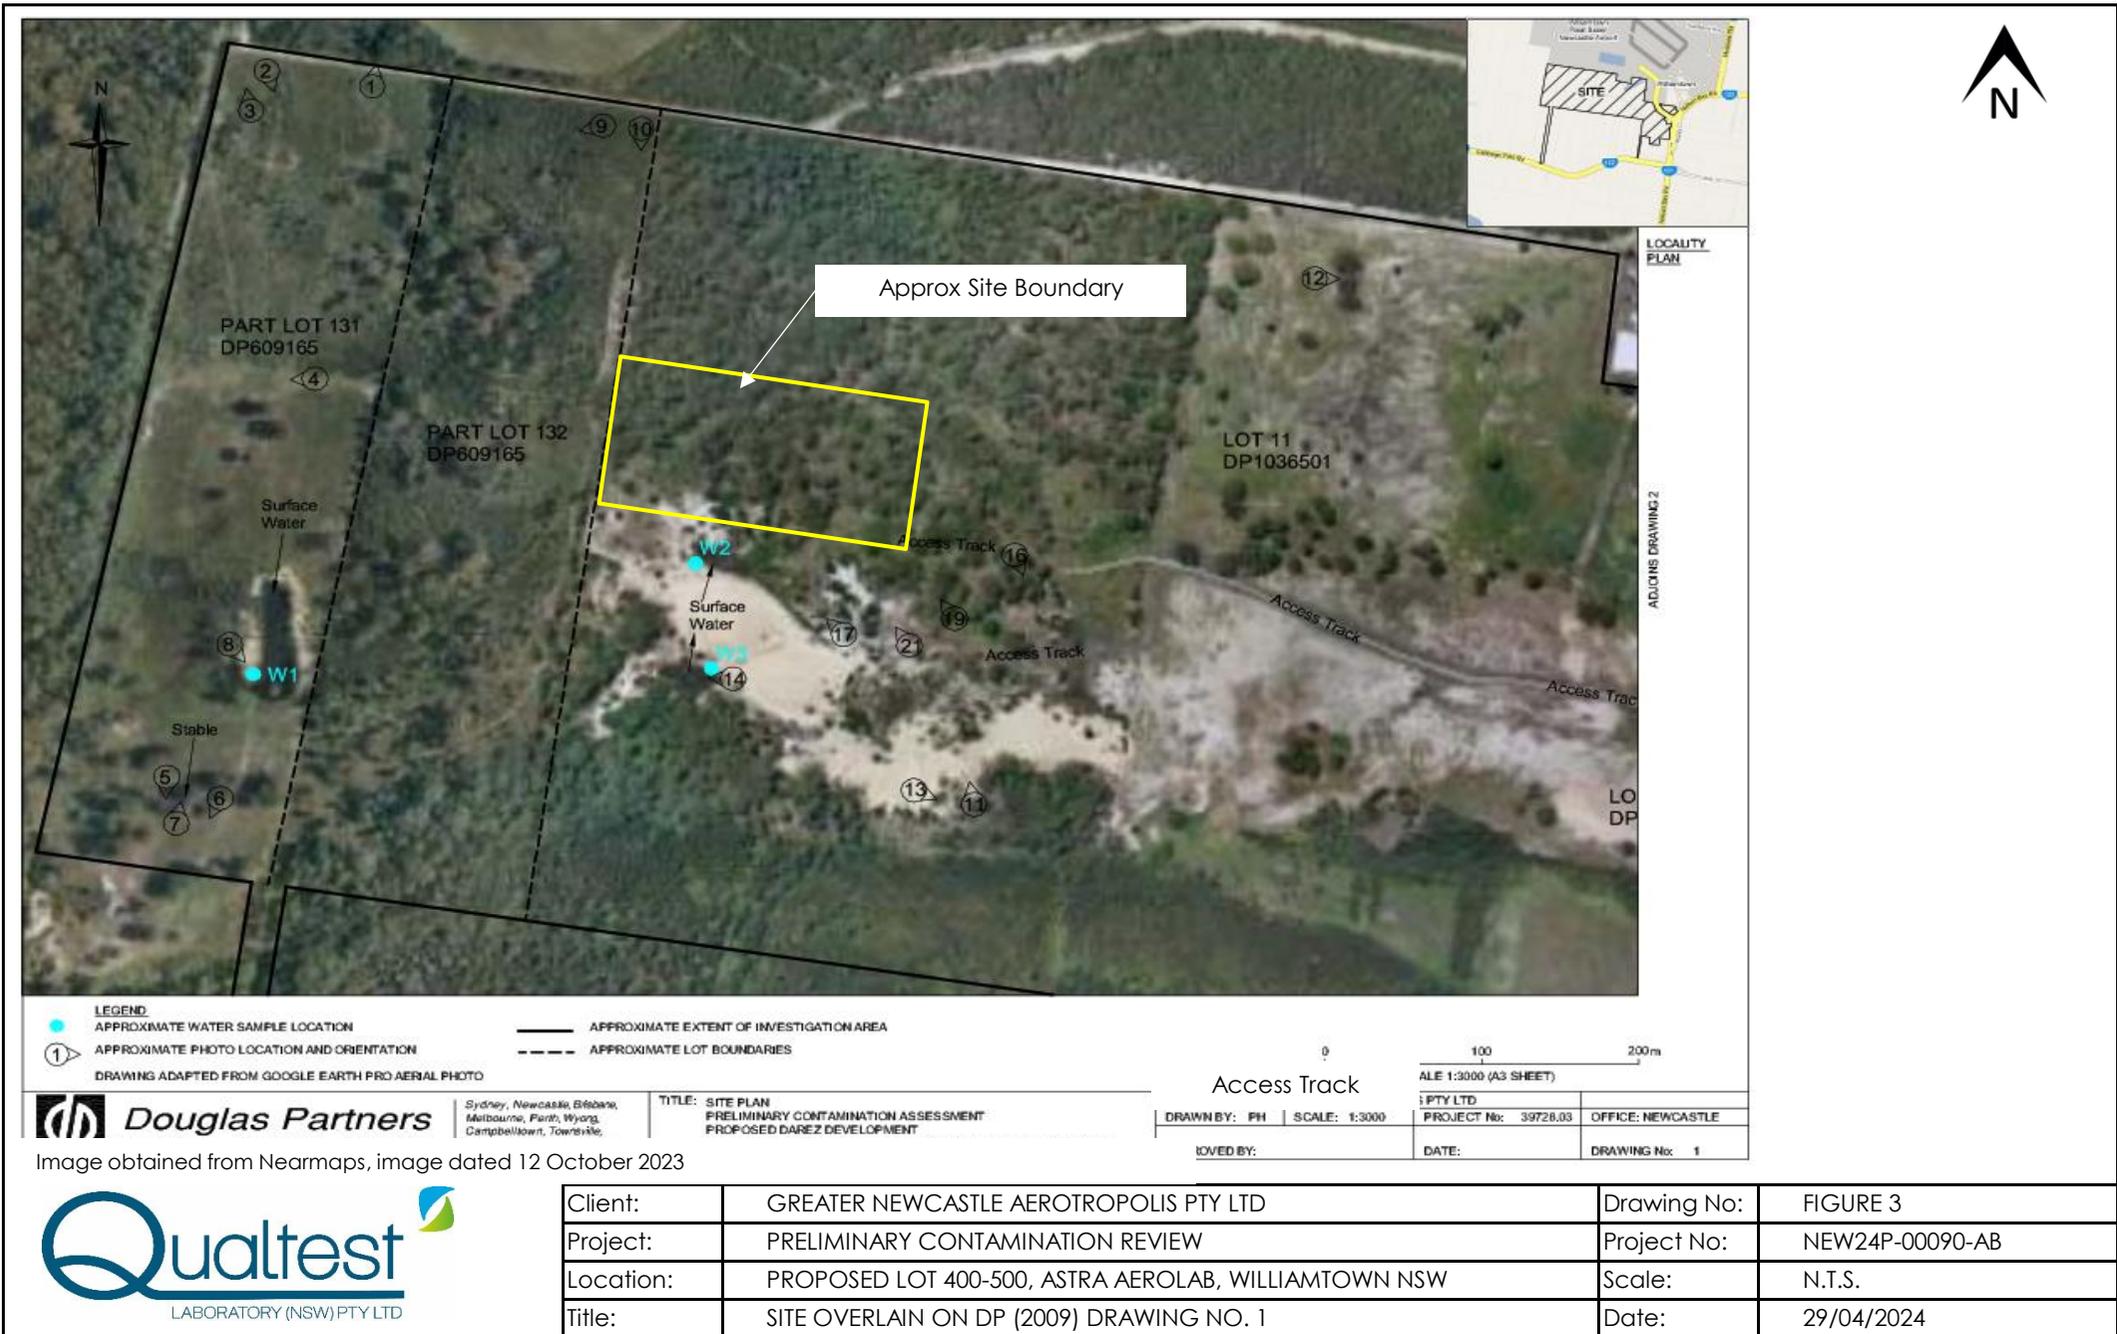
Client:	GREATER NEWCASTLE AEROTROPOLIS PTY LTD	Drawing No:	FIGURE 3
Project:	PRELIMINARY CONTAMINATION REVIEW	Project No:	NEW24P-00090-AB
Location:	PROPOSED LOT 400-500, ASTRA AEROLAB, WILLIAMTOWN NSW	Scale:	N.T.S.
Title:	SITE OVERLAIN ON DP (2009) DRAWING NO. 1	Date:	29/04/2024

DP were engaged to provide a PCA for the proposed Defence Airport Related Employment Zone (DAREZ) development in 2009. The PCA covered the larger Astra Aerolab precinct (approx. 86ha) which includes the current site (Lots 400-500). Relevant information for the current site from the report is summarised below. The site overlain on Drawing No. 1 from DP (2009) is presented as Figure 3, Appendix A.

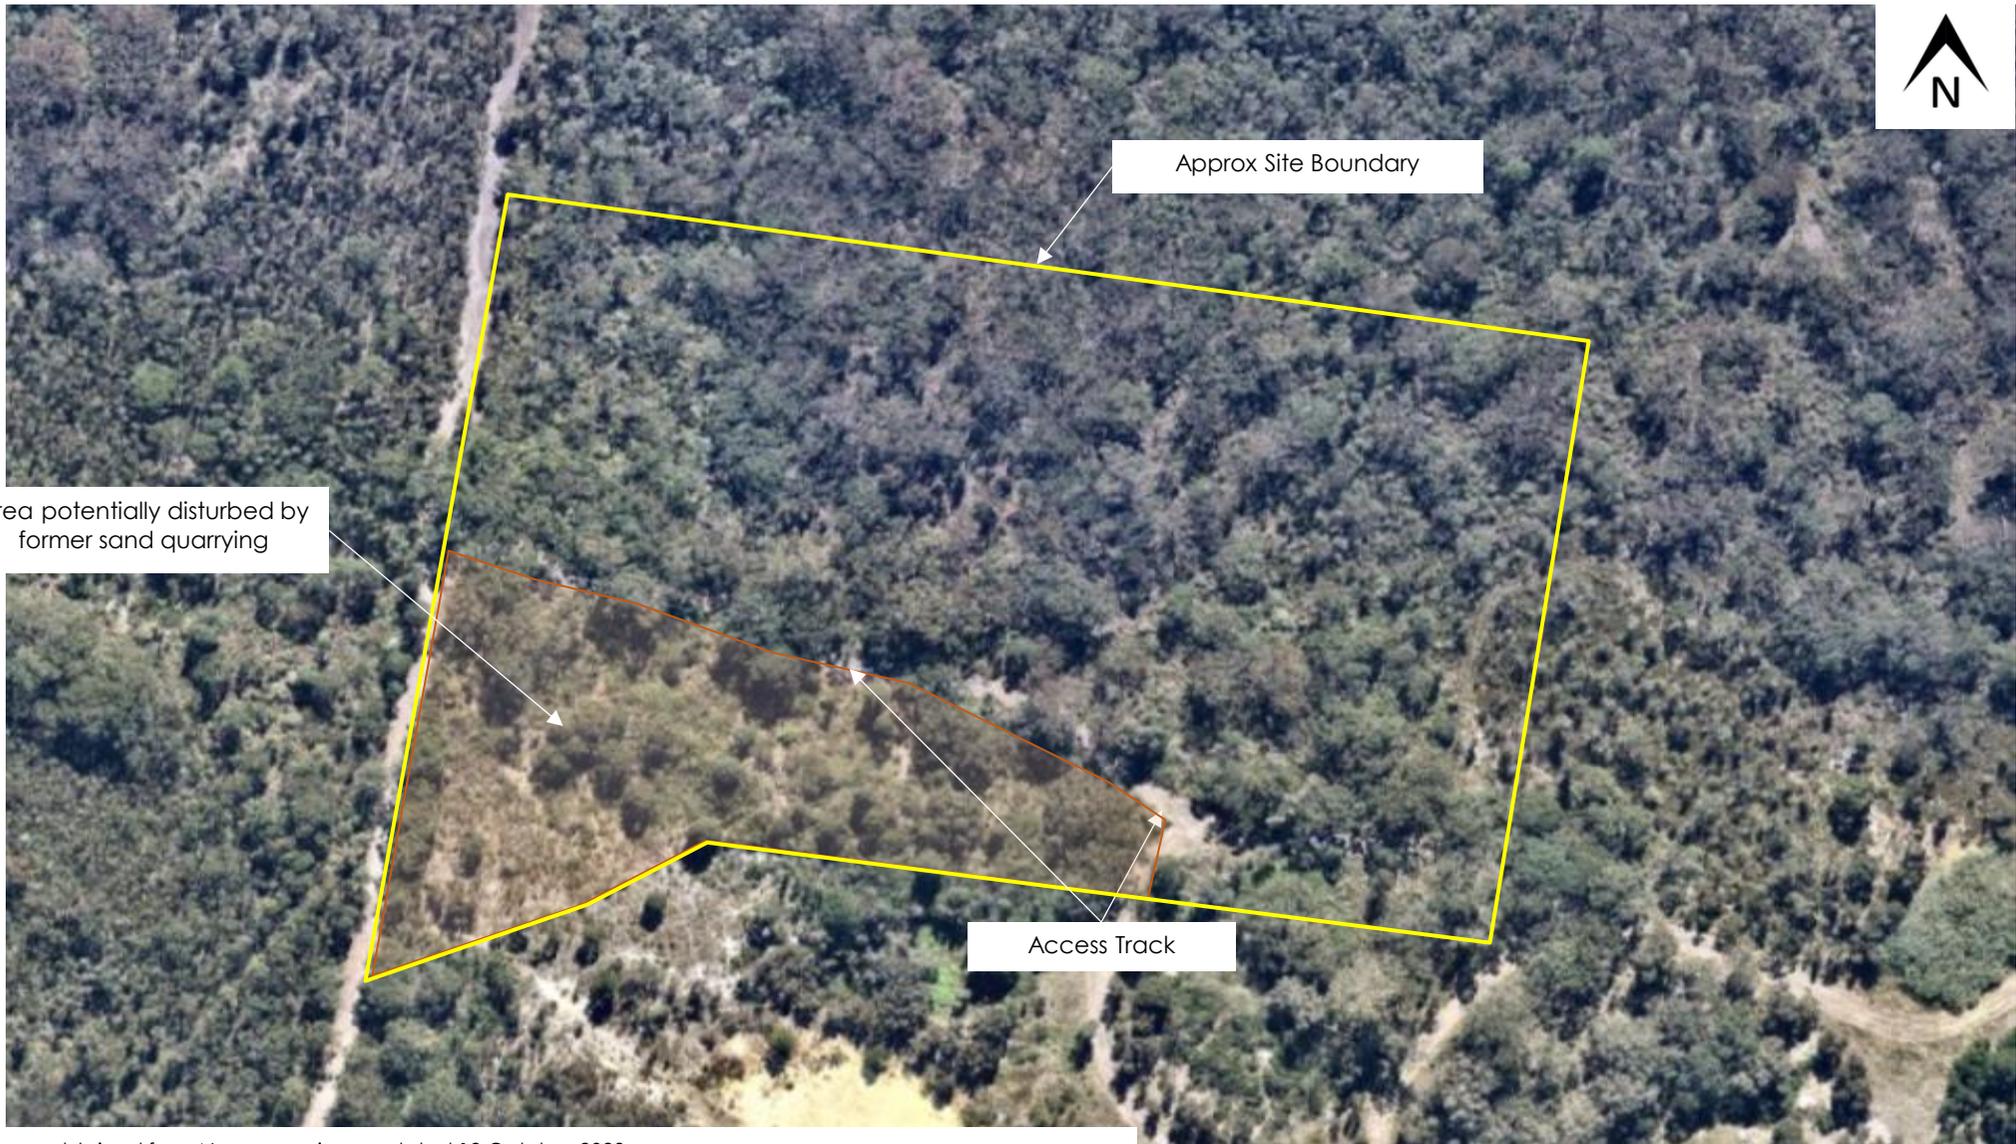
A Qualtest Senior Environmental Scientist visited the site on 1 May 2024. Selected site photographs are presented in Appendix D. The current site features are shown on Figure 4, Appendix A.

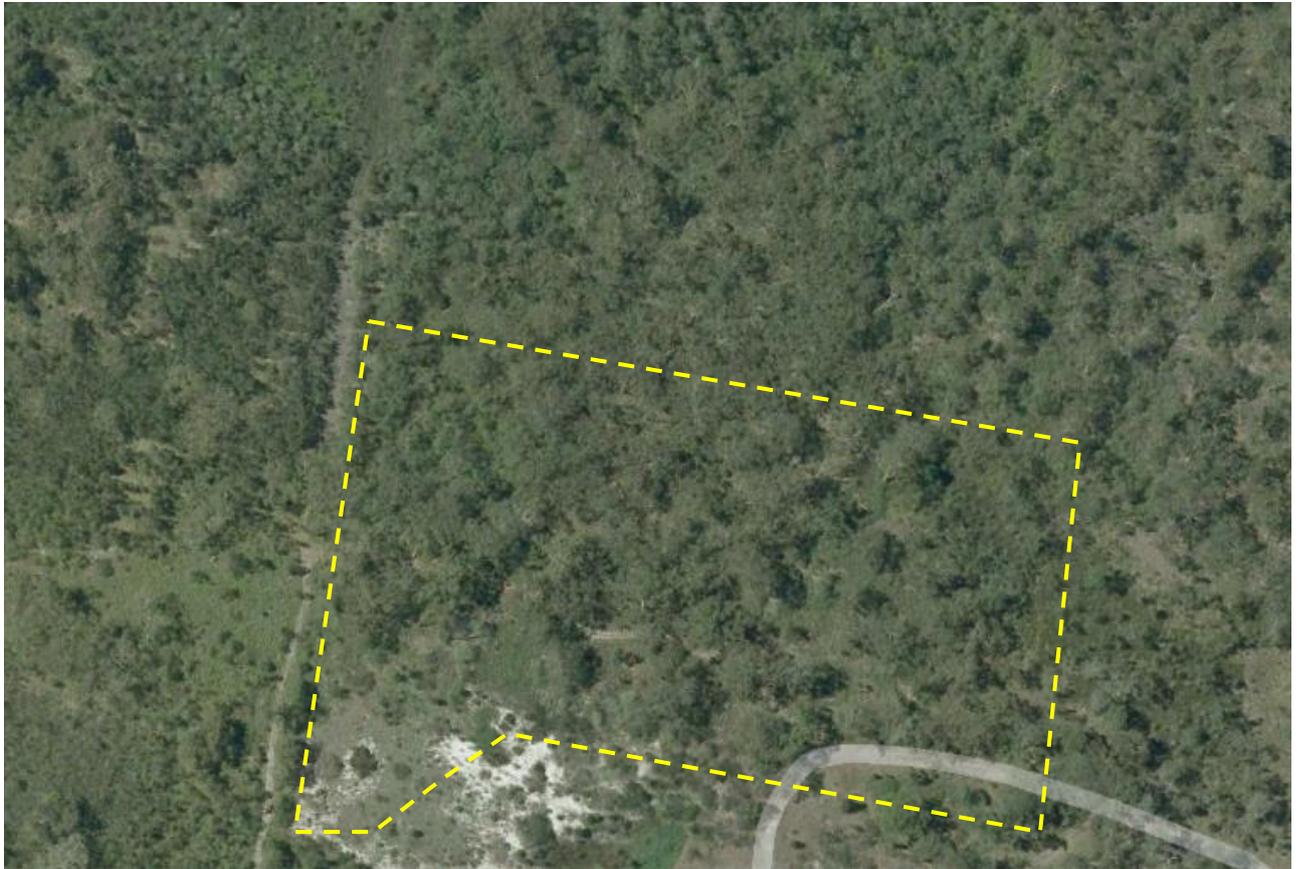
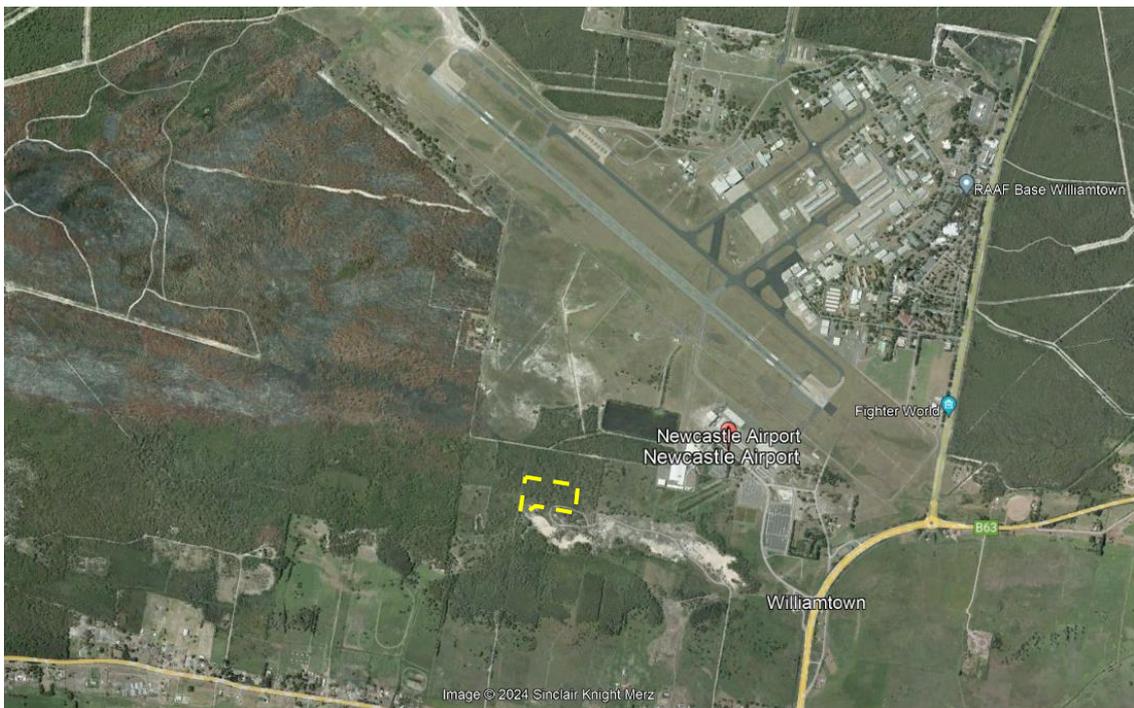
Year	Site	Surrounding Land
2010	The site appears to be undeveloped bushland.  Some land disturbance/exposed sand can be observed in the south-western portion.	The surrounding area appears to be undeveloped land to the north followed by Newcastle Airport land consisting of undeveloped land and air fields.  Vacant land followed by Newcastle Airport to the east consisting of a dam and car park facility.  Disturbed land to the south followed by undeveloped bushland.  Undeveloped bushland to the west.
2013	The site remains relatively unchanged from the 2010 aerial photograph.	The surrounding area appears similar to the 2010 aerial photograph.
2016	The site remains relatively unchanged from the 2013 aerial photograph.	The surrounding area appears similar to the 2013 aerial photograph.
2018	The site remains relatively unchanged from the 2016 aerial photograph.	The surrounding area appears similar to the 2016 aerial photograph.

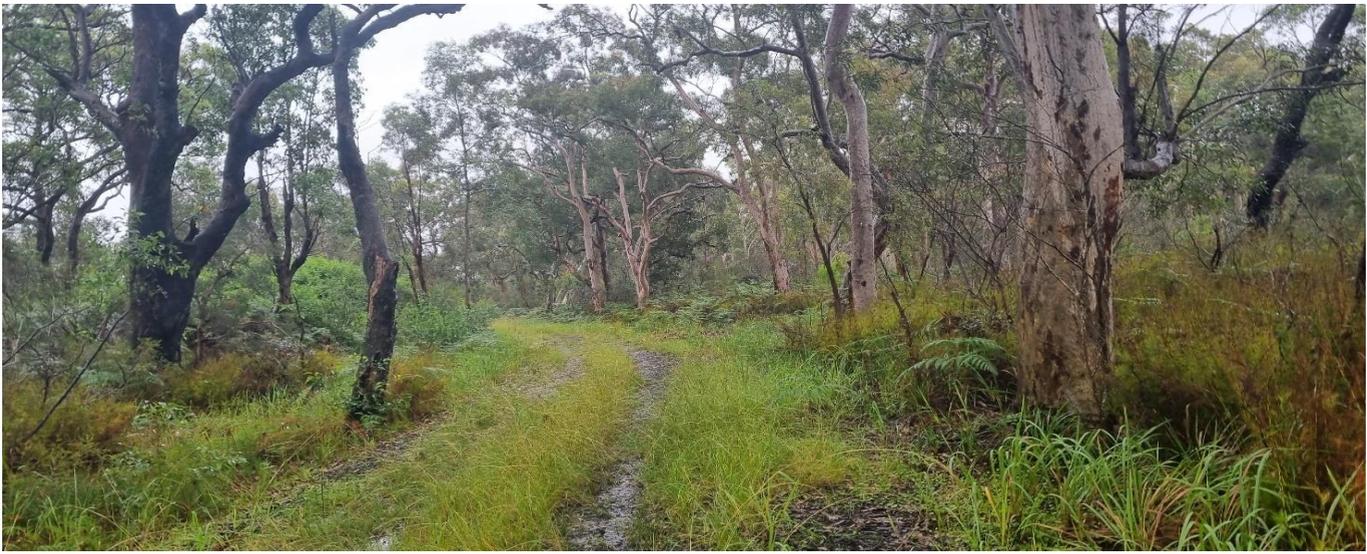
Photograph 1 - Showing access track and dense bushland on southern portion of site, facing west.

- The site is densely vegetated with trees, shrubs and grasses. Most of the site is inaccessible. See photographs 1 to 6.
- An access track runs along the southern portion/boundary of the site. The access track was paved with gravel, and occasionally some asphalt areas. See Photographs 1 and 3.

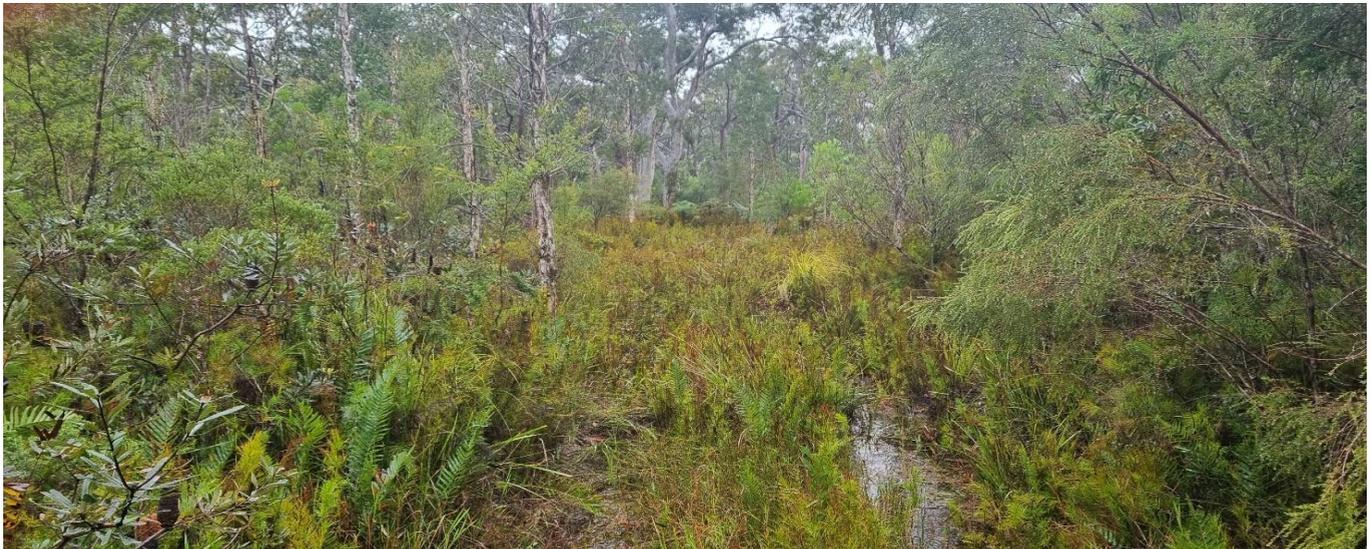
Photograph 2 - Showing vegetated track into bush in approx. central portion of site

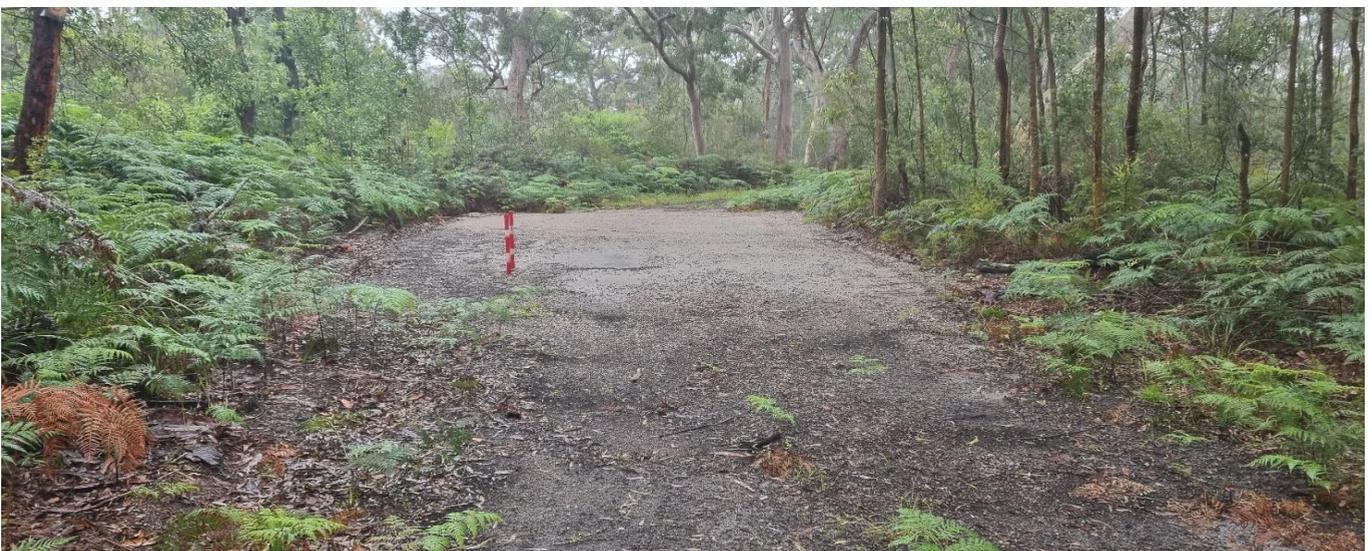
Photograph 3 - Showing access track area paved in asphalt on southern portion of site

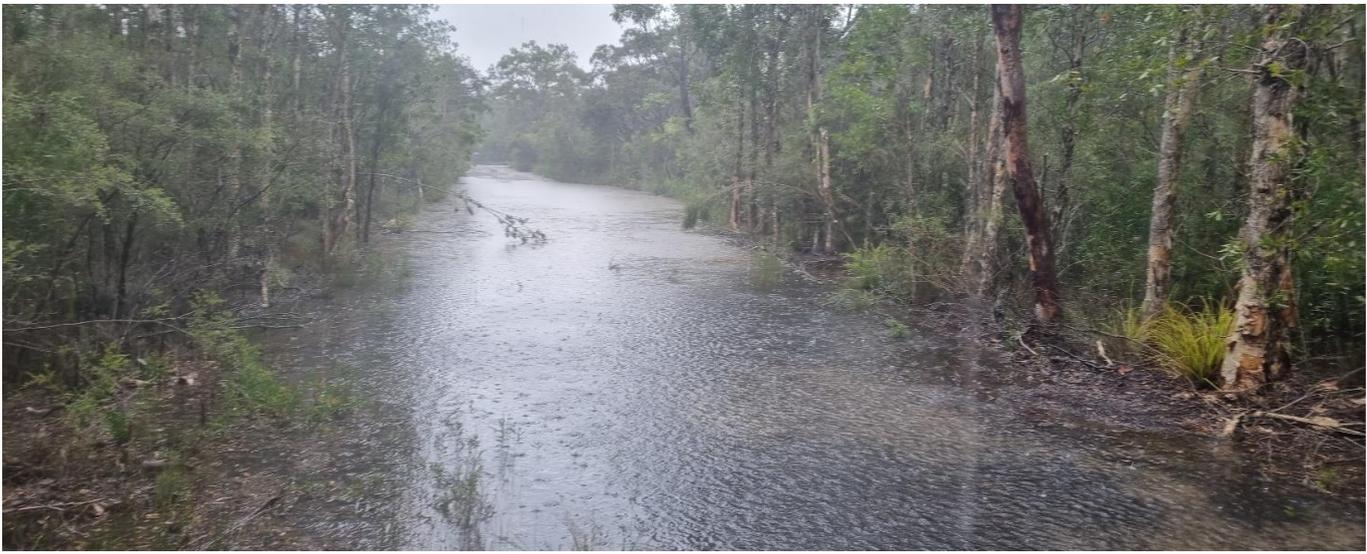
Photograph 4 - Showing access track on western boundary of site, facing north.

- An access track also runs along the western boundary of the site. The access track was paved with gravel. See Photographs 4 and 5.

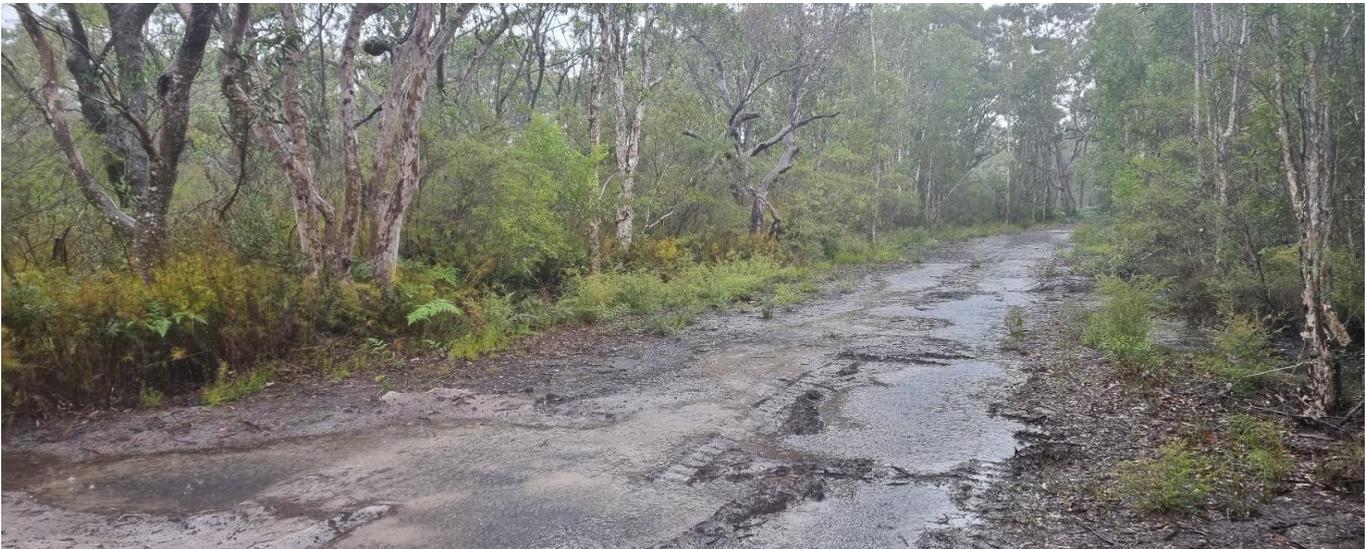
Photograph 5 - Showing access track on western boundary of site, facing south.

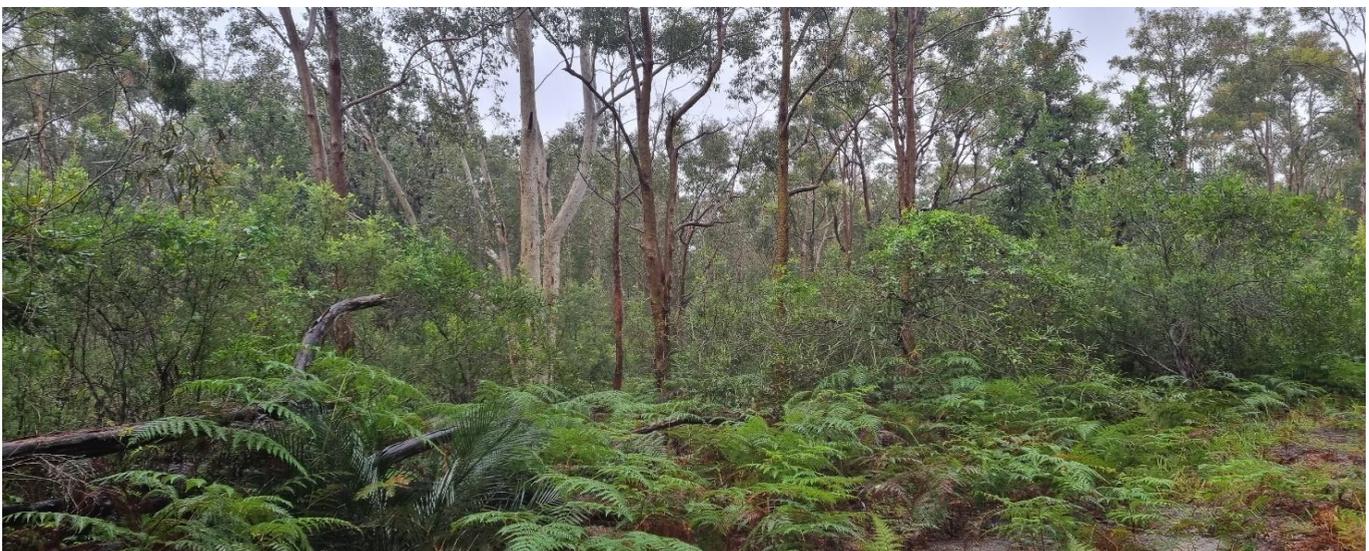
Photograph 6 - Showing dense bushland in south-western portion of site
